# Manhole Inspection Summary

Manhole # S15AA2042MH

**Location** Address: **CARTERDALE RD**

Cross Street: **ROGERS AVE**

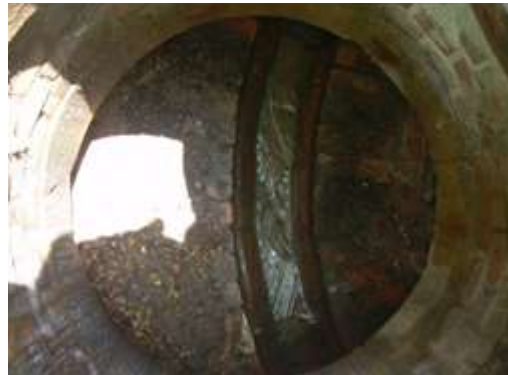
Top View

Evidence of surcharge - Bench debris.

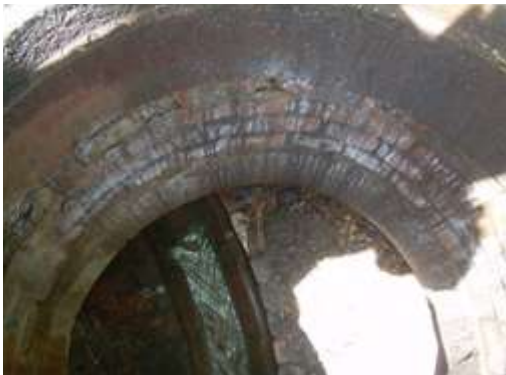
Defect

Frame leaks. Adjustment deterioration and infiltration. Corbel infiltration - other side.

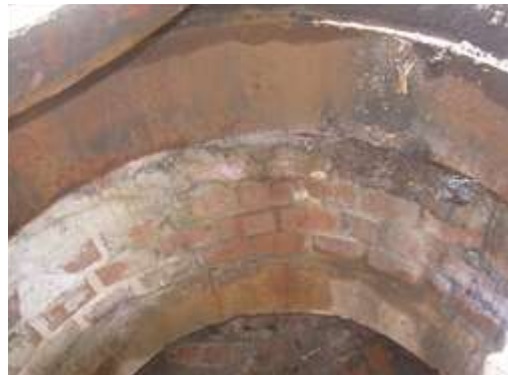
Defect

Frame leaks. Adjustment deterioration and infiltration. Corbel infiltration.

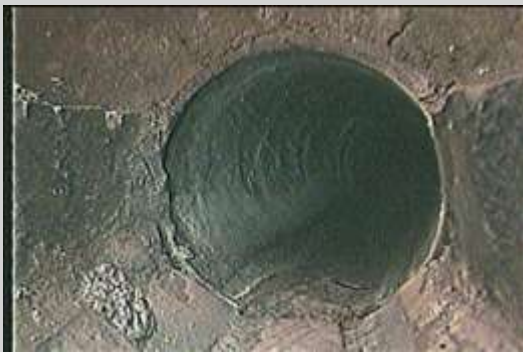
### 8 in. Circular Gravity Sewer Pipe Out @ 12 O'Clock

Infiltration: **Evidence** Pipe Seal Cond: **Cracked**

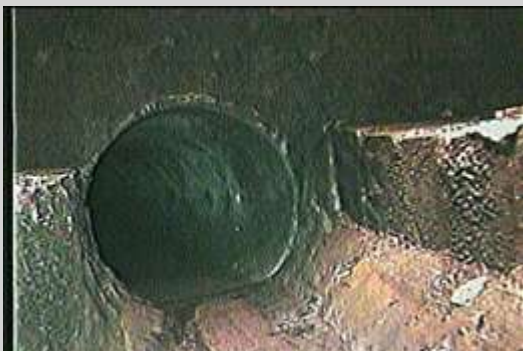
### 8 in. Circular Gravity Sewer Pipe In @ 5 O'Clock

Barrel deterioration and infiltration.

Infiltration: **Evidence** Pipe Seal Cond: **Cracked**
